Inspection Report

Minerals Regulatory Program Date of Report: December 3, 2007

Mine Name: Bonanza Operator Name: American Gilsonite	Permit number: M0470010 Inspection Date: November 27, 2007 Time: 10:00 AM to about 12:30 PM				
Inspector(s): Paul Baker Other Participants: Jared Jackson, American Gilsonite Mine Status: Active	icipants: Jared Jackson, American Gilsonite				
Elements of Inspection	Evaluated	Comment	Enforcement		
 Permits, Revisions, Transfer, Bonds Public Safety (shafts, adits, trash, signs, highwalls) 					
3. Protection of Drainages / Erosion Control4. Deleterious Material					
5. Roads (maintenance, surfacing, dust control, safety)					
6. Concurrent Reclamation					
7. Backfilling/Grading (trenches, pits, roads, highwalls, shafts, drill holes)					
8. Water Impoundments					
9. Soils					
10. Revegetation	\boxtimes				
11. Air Quality					
12. Other	\boxtimes	\boxtimes

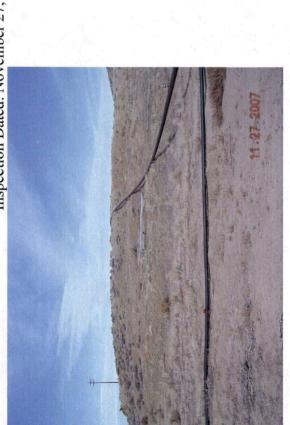
Photo 1. B-40.

Site B-40 (Photo 1) has a moderate amount of greasewood, big sage, and rabbitbrush, but most of the vegetation is cheatgrass and halogeton (now dead). I did not measure cover, but it appeared to be similar to that found in some of the adjacent undisturbed areas.

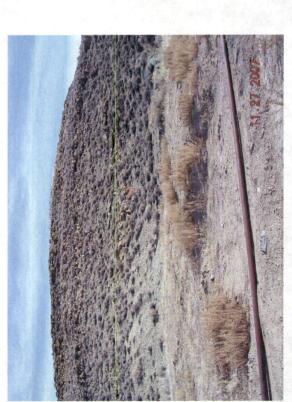
- Sites listed as WH-10 through WH-13 are actually just WH-11 and WH-12 with small escapeways.
- LE-19 is a typical one-acre site. It is not three acres as shown in the bond calculation.
- The BLM holds a bond of \$23,613 for LE-5, but Mr. Jackson said this should probably be for three sites, LE-5, LE-6, and LE-7. LE-5 is reclaimed, and the cap was buried in 2006. LE-6 is inactive but has a full set of equipment. LE-7 is a small escapeway surrounded by a chain link fence.

Photo 2. LE-5. 2006 reclamation

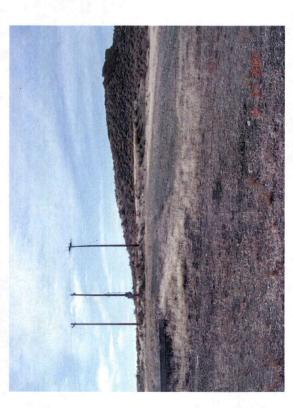
Photo 5. LE-10.

In a letter dated March 7, 2007, the Division stated that revegetation still needs to be accomplished at sites B-40, WH-12, LE-10, LE-16, LE-19, and LE-20. The operator responded that he felt these sites had adequate vegetation. LE-10 is typical of these sites (except B-40) and is shown in Photo 5.

Vegetation at the other sites consists primarily of cheatgrass and halogeton with a few scattered plants of snakeweed, rabbitbrush, and big sage.

Vegetation cover at sites WH-12, LE-10, LE-16, LE-19, and LE-20 is probably about the same as in nearby undisturbed areas, but the problem is that there is little perennial cover meeting a wildlife habitat or grazing postmining land use. The Division normally uses cover values from non-weedy vegetation to compare reclaimed and undisturbed areas.

I recommend that the operator modify the revegetation plan to include some aggressive grasses in addition to some native species. Among the species the operator should consider are (rates given are in pounds of pure live seed per acre): "Hycrest" crested wheatgrass (3 pounds), forage kochia (0.5 pounds), bottlebrush squirreltail (1 pound), winterfat (2 pounds), and fourwing saltbush (3 pounds). I also recommend that the seeding rates for the species in the current seed mix be reduced to 0.5 pounds for Wyoming big sage, 1 pound for needle-and-thread grass, and 2 pounds of shadscale.

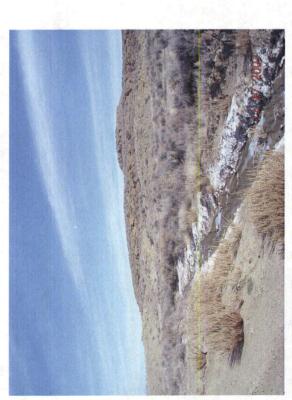
We crossed a drainage that had a lot of salt crust on the banks (Photo 6), and this drainage apparently carries water from a mine water discharge. Mr. Jackson said the TDS limit is 3500 ppm, and the two lab reports in the Division's file show TDS values of 2650 and 2800 ppm.

Photo 6. A drainage channel that carries water from a mine water discharge point. Note the salt crusts on the banks.

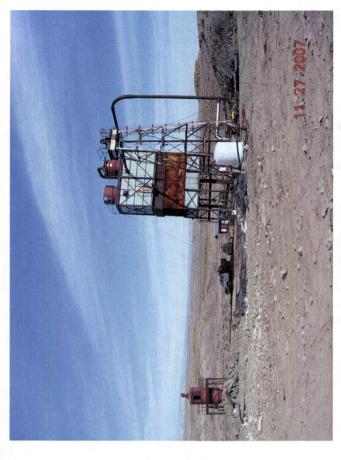
Photo 7. B-48.

Soil has been stockpiled at site B-48.

Site B-48 is currently under construction (Photo 7).

The soil stockpile at B-48 should be seeded this fall with a seed mix designed to provide erosion control and interim vegetation cover.
